**MOTORCYCLE ACCIDENT CAUSATION AND  
IDENTIFICATION OF COUNTERMEASURES  
IN THAILAND  
VOLUME II: UPCOUNTRY STUDY**

SEPTEMBER 2001  
FINAL REPORT

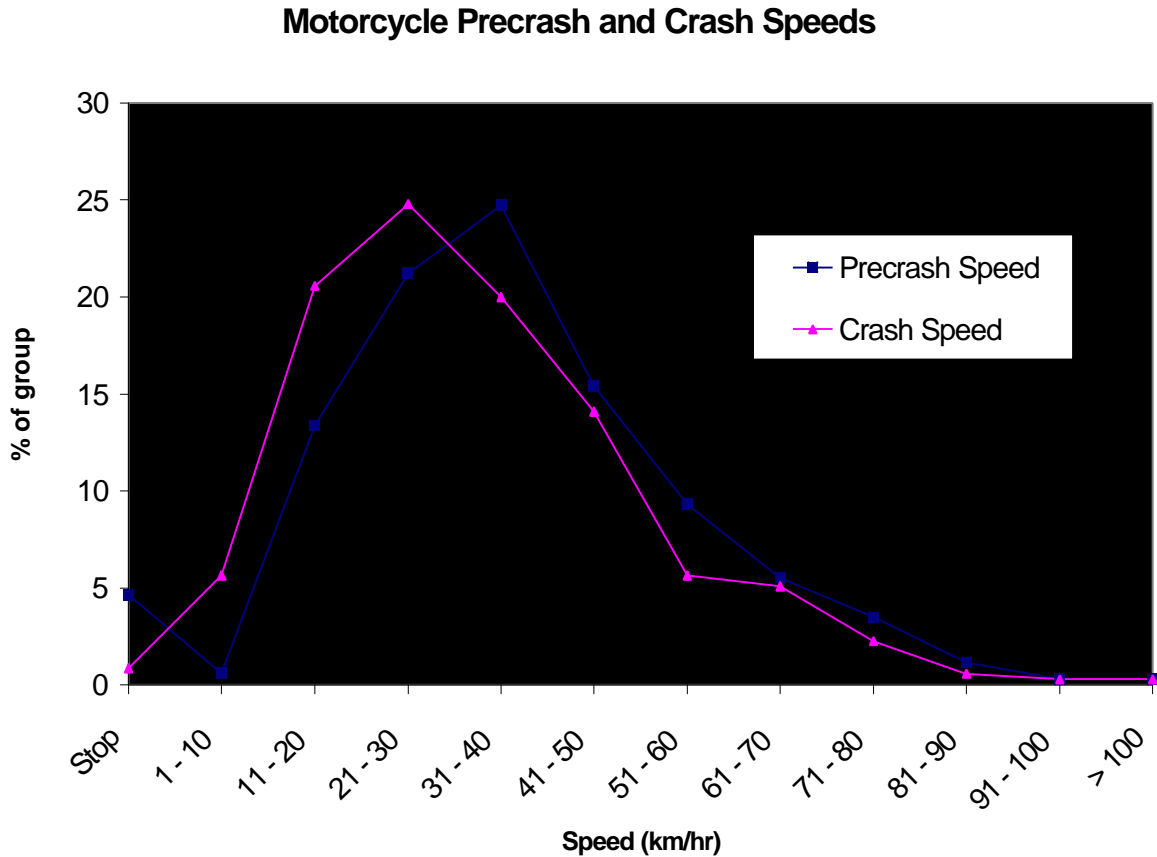
Pre-crash speeds ranged from 0 to 124 km/hr, with a median speed of 35 kilometres per hour for all 359 cases. One-fourth of the cases had a pre-crash speed below 25 km/hr, and another one-fourth had a pre-crash speed above 50 km/hr.

Crash speeds averaged about 5 km/hr less than pre-crash speeds and had the same range of 0 to 124 km/hr. The median crash speed was 30 km/hr. One fourth of the crash speeds were below 20 km/hr, and another 25% were above 45 km/hr. Table 7.2.2 shows the distribution of crash speeds. The percent distribution of motorcycle pre-crash and crash speeds is shown in Figure 7.2.1. The data illustrated in Figure 7.2.1 can be seen in the Appendix as Table 7.2.1.

**Figure 7.2.1: Percent distribution the pre-crash and crash speeds of the accident-involved motorcycles.**

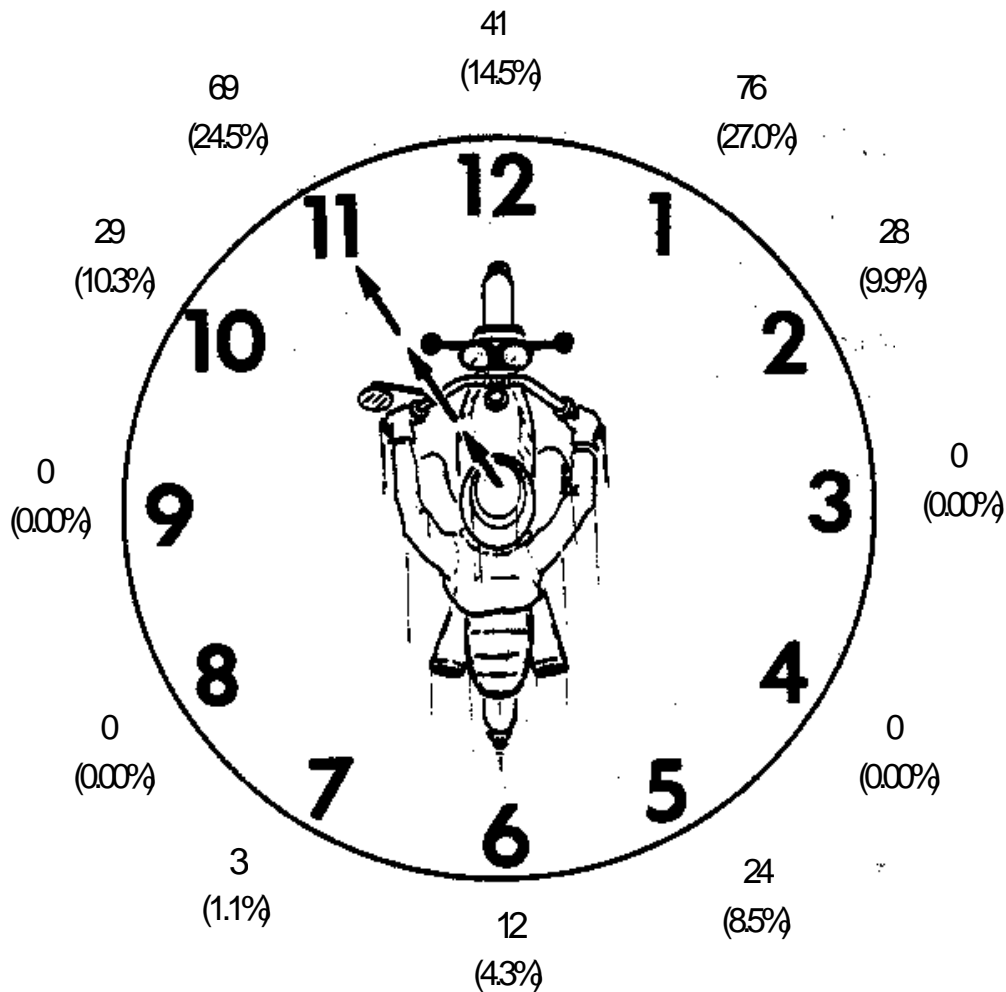
Figure 7.3.1 shows the distribution for the pre-crash lines-of-sight from the motorcycle to the other vehicle for the 292 cases that involved another vehicle. No data regarding line-of-sight was coded for single vehicle collisions or for any cases where the motorcycle impacted a pedestrian, an animal or a fixed object.

The highest concentration of line-of-sight orientations was at 1 o'clock, followed by 11 and 12 o'clock, with two-thirds of the hazards in that one quadrant in front of the motorcycle rider. When the line-of-sight from the motorcycle to other vehicle is in the 11-12-1 o'clock range, the other vehicle driver would see mainly the front end of the motorcycle. Therefore, improvements in conspicuity should focus on the front of the motorcycle and the rider.

**Figure 7.3.1: Pre-crash line-of-sight from motorcycle to the other vehicle**

The 11% of accidents that occurred with a pre-crash line-of-sight in the 5-6-7 o'clock quadrant also suggest the need for more conspicuous rear lamps and rear reflectors.

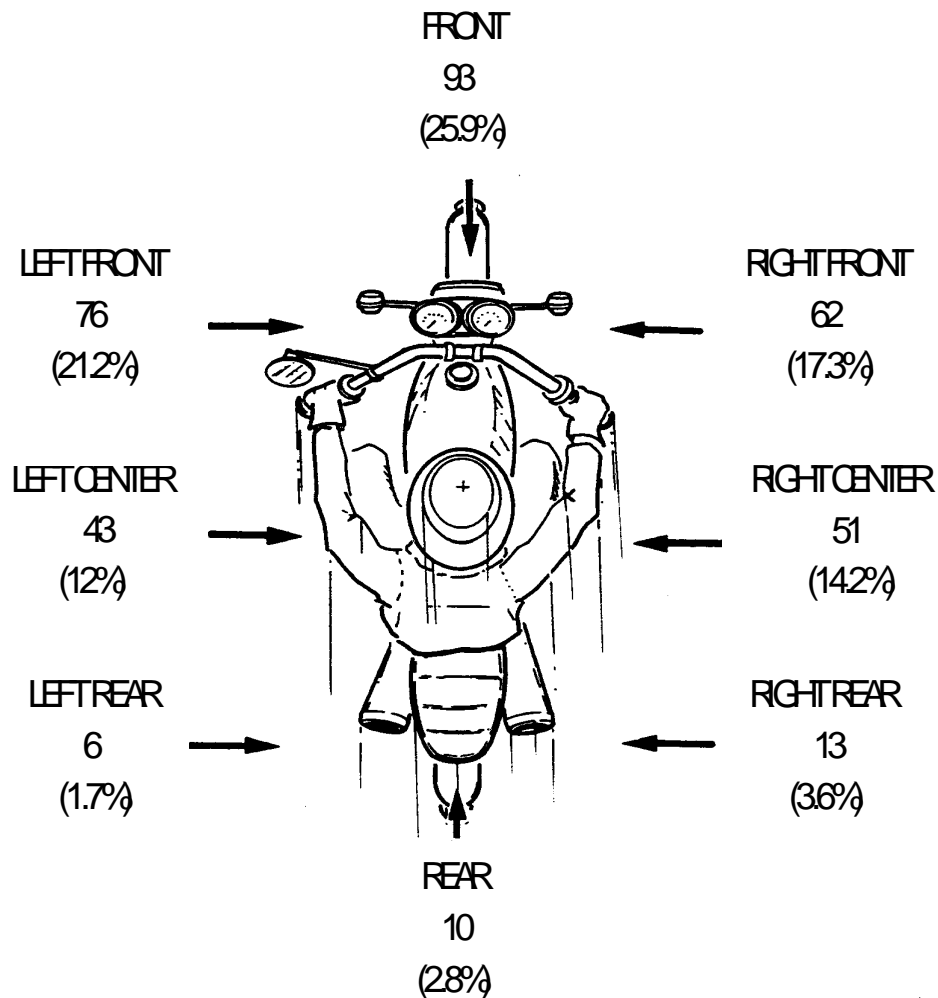
Figure 7.8.1 shows the distribution of first collision contacts for the 359 on-scene, in-depth accident investigation cases. In about one-fourth of cases, the collision contact was located at the center front of the motorcycle, including the front tyre and wheel, fender, and forks. Another 21% and 17% of collision contacts were at the left and right front of the accident-involved motorcycle. When these three regions are combined, about two-thirds of the motorcycle collision contacts were frontal impacts.

Fig. 7.8.1: First collision contact on the accident-involved motorcycle

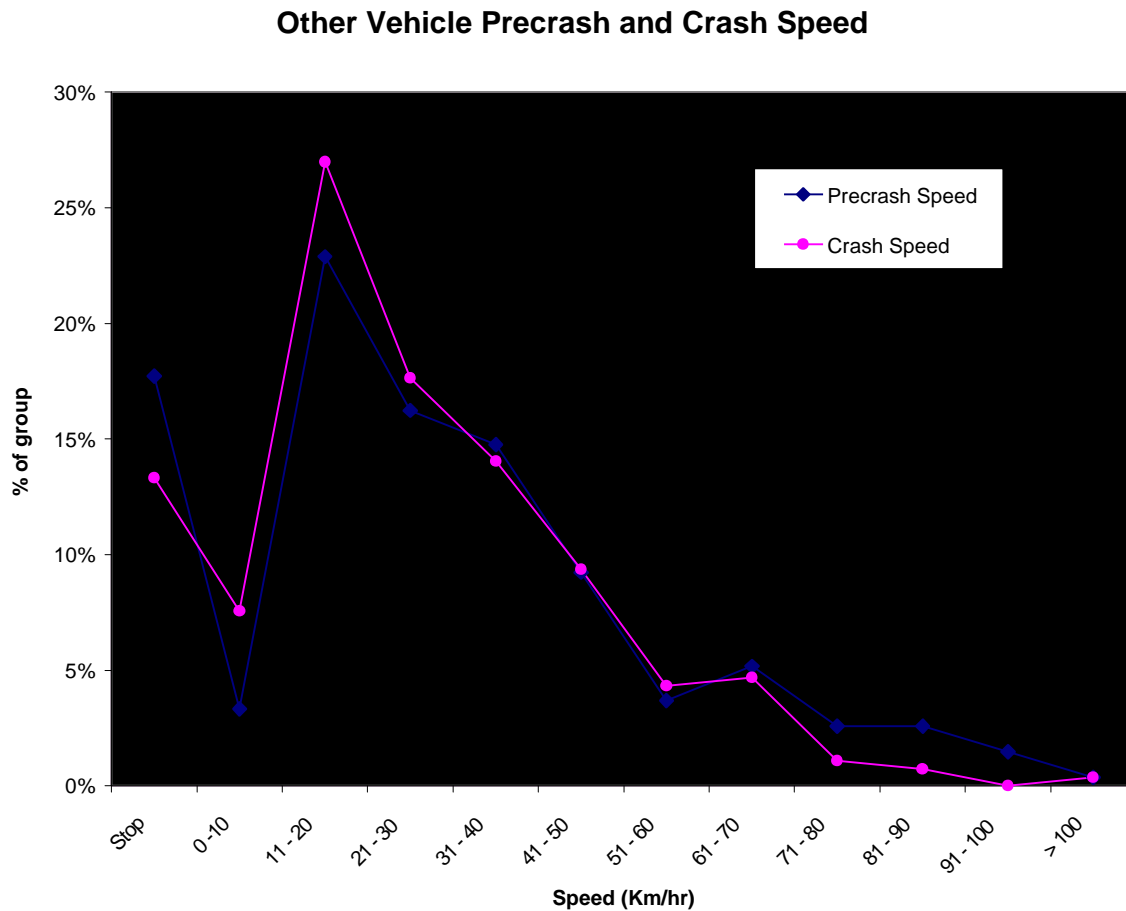
The median pre-crash speed was found to be 24 km/hr and the median impact speed was 21 km/hr. The pre-crash speed was not known in 37 cases (12%) due to insufficient physical evidence or a hit-and-run situation. The relationship between the pre-crash and crash speeds is illustrated in Figure 7.12.1.

**Fig. 7.12.1: The distribution of other vehicle pre-crash and crash speeds**

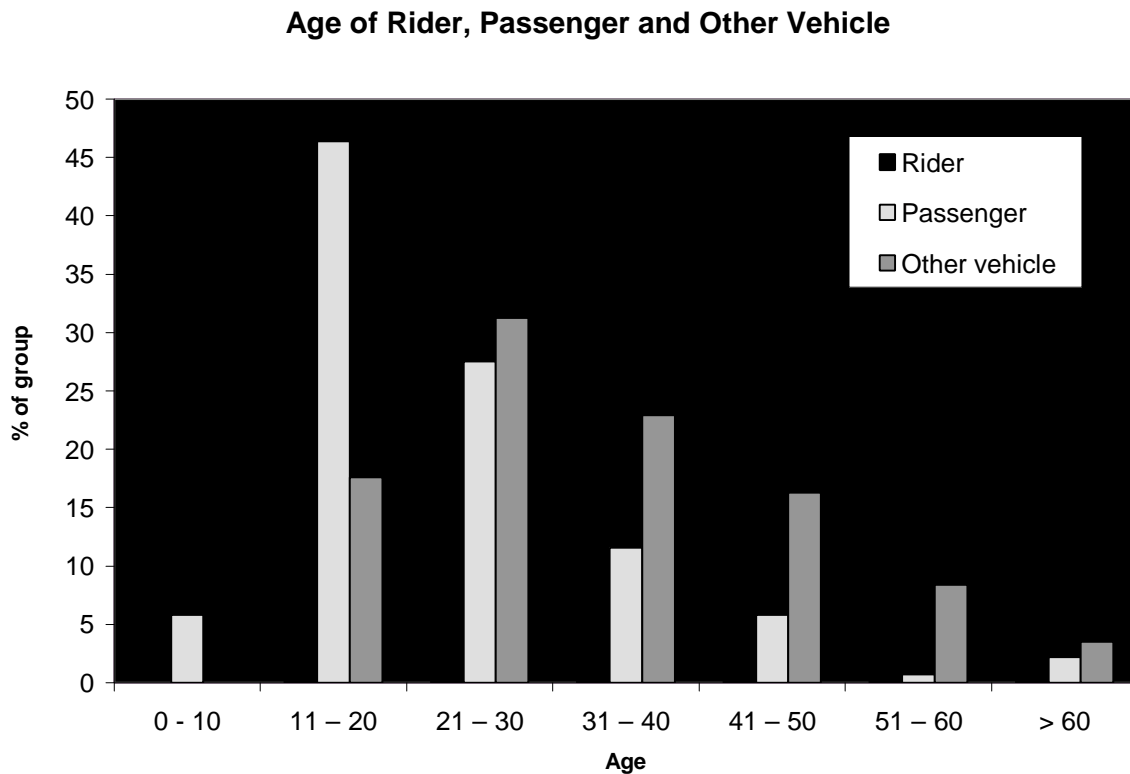
**Figure 8.1.1: Percent distributions of rider, passenger and OV driver age**

Other vehicle drivers tended to be older than motorcycle riders and passengers, with a median age of 31 years. About 43% of the drivers were 21 to 40 years and for 20% age was unknown, usually because they fled the scene after the crash. The age distribution of the motorcycle riders, passengers and other vehicle drivers is shown in Figure 8.1.1. Data underlying Figure 8.1.1 is presented in Table 8.1.1 in the Appendix.

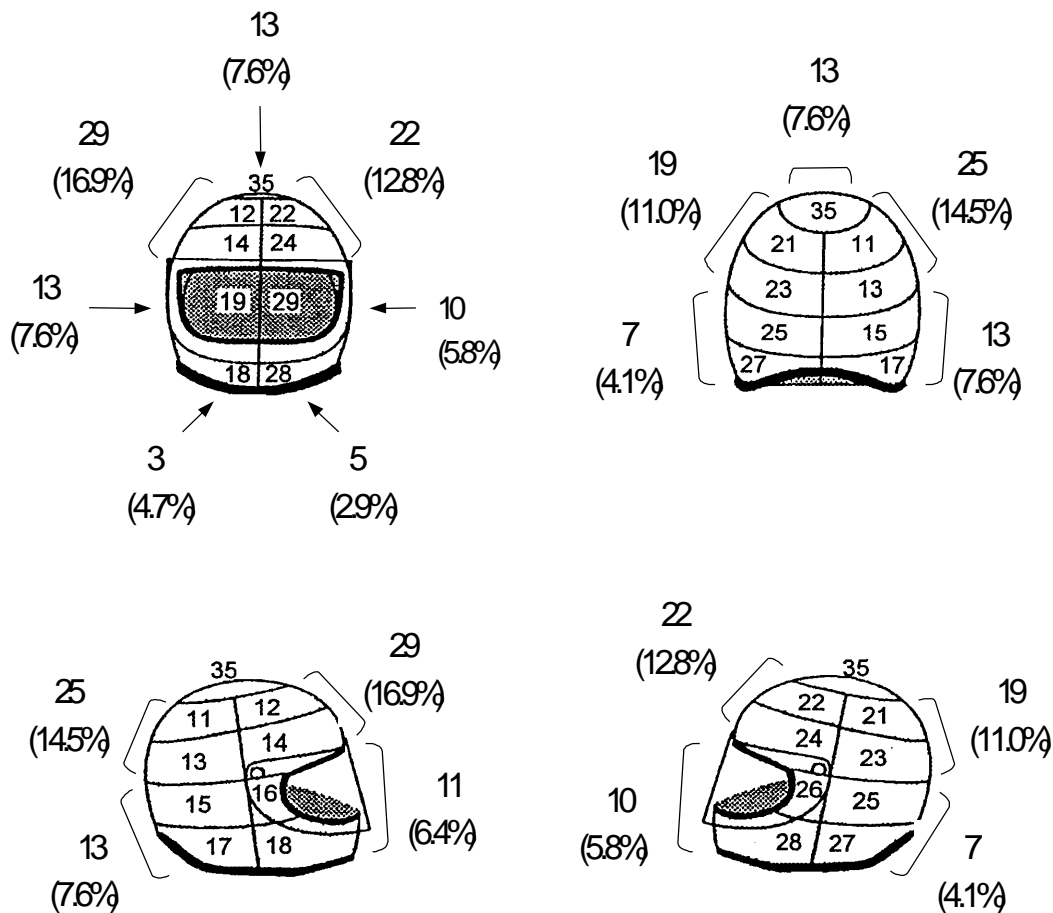
The locations of the impact sites on the motorcycle safety helmet were divided into 10 locations and were numbered as shown in Figure 10.5.1.

Damage was found more often on the right than on the left side of the helmet (53% versus 40%). The upper front region was impacted 30% of the time, the upper rear 25% of the time. Impacts to the lower front and lower rear both were about 12%. Because a helmet could be impacted in more than one region, and all impact locations were recorded, the number of impacts listed is not the same as the number of helmets worn.

ure 10.5.1: Designation of helmet regions used to code impact locations

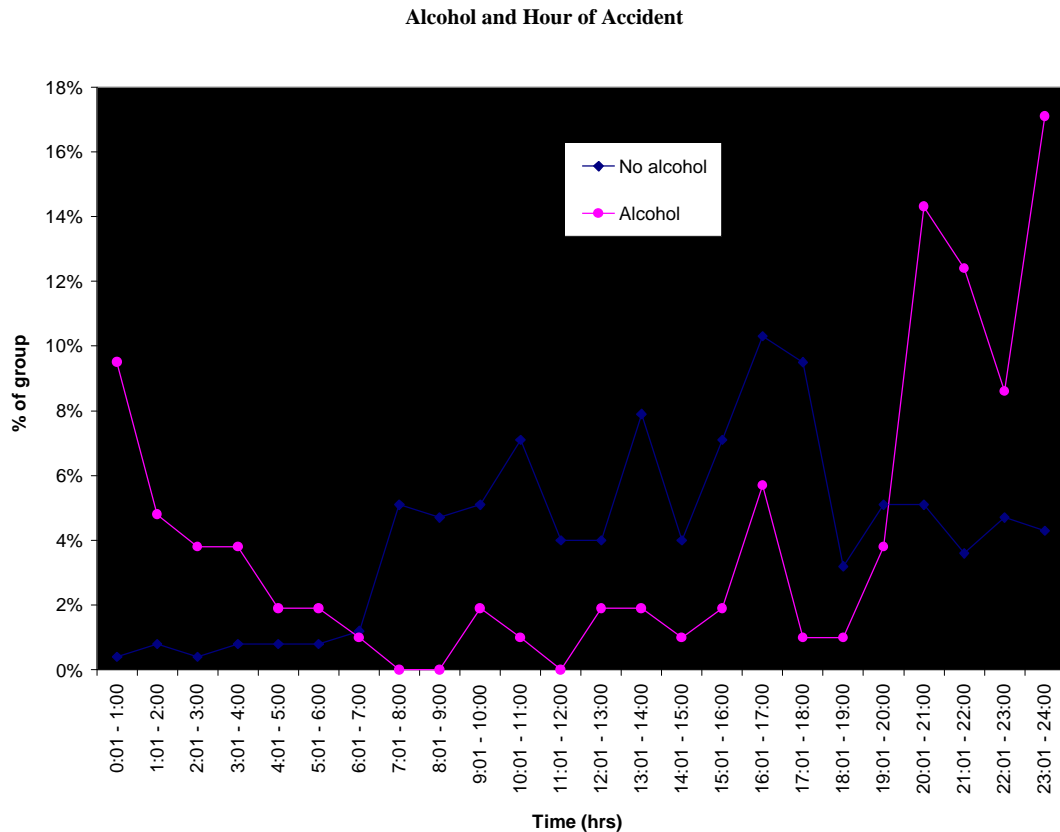
Figure 11.3.1: Percent distribution of accident times in alcohol and non-alcohol accidents

As in Bangkok, alcohol-involved accidents in the upcountry sampling region tended to occur mostly at night. However, in upcountry accidents, the peak frequency was found to occur in the few hours around 10 p.m. where 65 of 105 cases (62%) happened between 8 p.m. and 1 a.m. Figure 11.3.1 shows the time distribution of alcohol and non-alcohol accidents. The data are shown in Table 11.3.2 in the Appendix.
